# Manhole Inspection Summary

Manhole # S17I\_\_012MH

Insp Date: **2/27/08 8:28 AM**

**Location** Address: **2501 booth st**

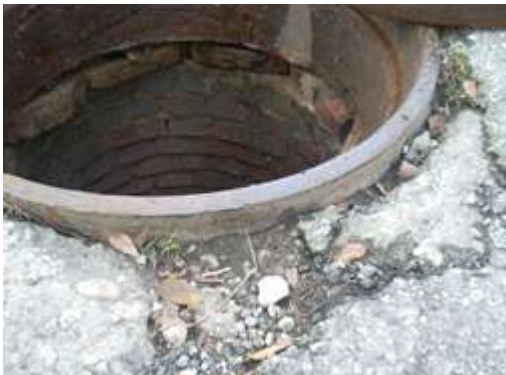
Misc

above grade, ground around the frame is deteriorated

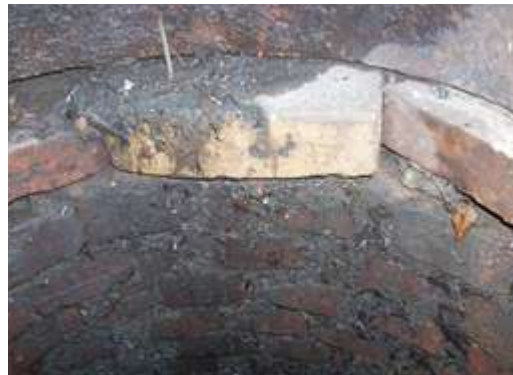
Defect 5

Infiltration: ☐ None ☒ **Joint** ☐ Cracks ☐ Mortar ☐ Roots ☐ Wall

infiltration from the corbel joint

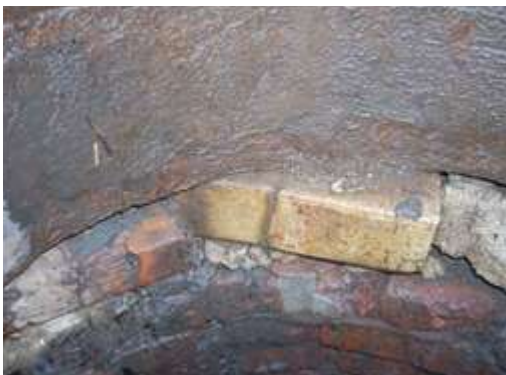
Defect 4

Condition: ☐ Sound ☒ **Cracked** ☐ Root Intrusion ☐ Loose Brick ☐ Deteriorated

cracked chimney bricks

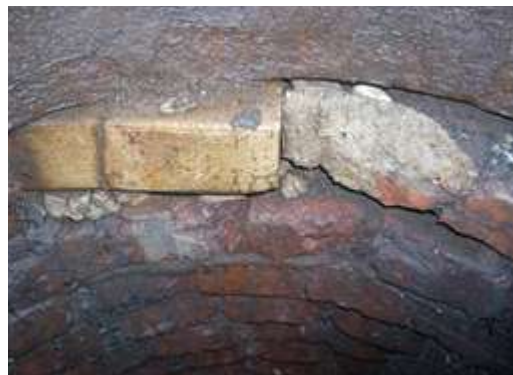
Defect 3

Condition: ☐ Sound ☐ Cracked ☐ Root Intrusion ☐ Loose Brick ☒ **Deteriorated**

deteriorated corbel

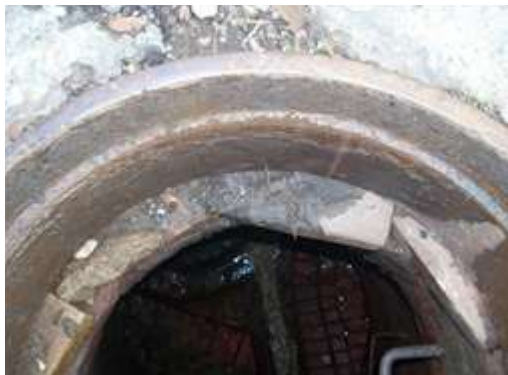
### Defect 1

Offset: **4** (in.)

frame offset

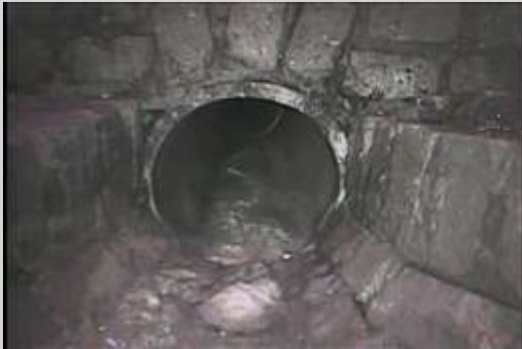
12 O'Clock Outflow

Pipe Height: **8.4** (in.) Rod and Bar (Angled)  
Pipe Material: **Clay** ☐ Pipe Lined  
Invert Depth: **8.55** (ft.) Flow Characteristics: **Slow**  
Deposits: ☒ None ☐ **Mud** ☐ Sludge ☐ Debris ☐ Grease  
Silt Depth: **0** (in.) Deposits Extent:  
Infiltration: **Evidence** Pipe Seal Cond: **Sound**

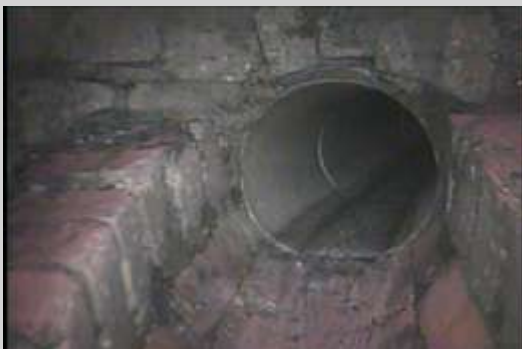
6 O'Clock Inflow

Pipe Height: **8.4** (in.) Rod and Bar (Angled)  
Pipe Material: **Clay** ☐ Pipe Lined  
Invert Depth: **7.97** (ft.) Flow Characteristics: **Slow**  
Deposits: ☒ None ☐ **Mud** ☐ Sludge ☐ Debris ☐ Grease  
Silt Depth: **0** (in.) Deposits Extent:  
Infiltration: **Evidence** Pipe Seal Cond: **Sound**

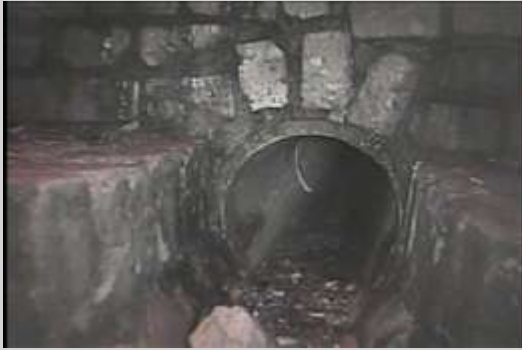
9 O'Clock Inflow

Deposits: ☐ None ☒ **Mud** ☐ Sludge ☐ Debris ☐ Grease

Silt Depth: **1** (in.) Deposits Extent: **Light**
